Adjusting the radial alignment a Tandon TM100 -2A drive without an alignment disk

Aligning a full-height floppy disk drive when the alignment screw proves inadequate. Check the stepper motor coupling!

Fixing a Tandon TM100 drive on a Kaypro II

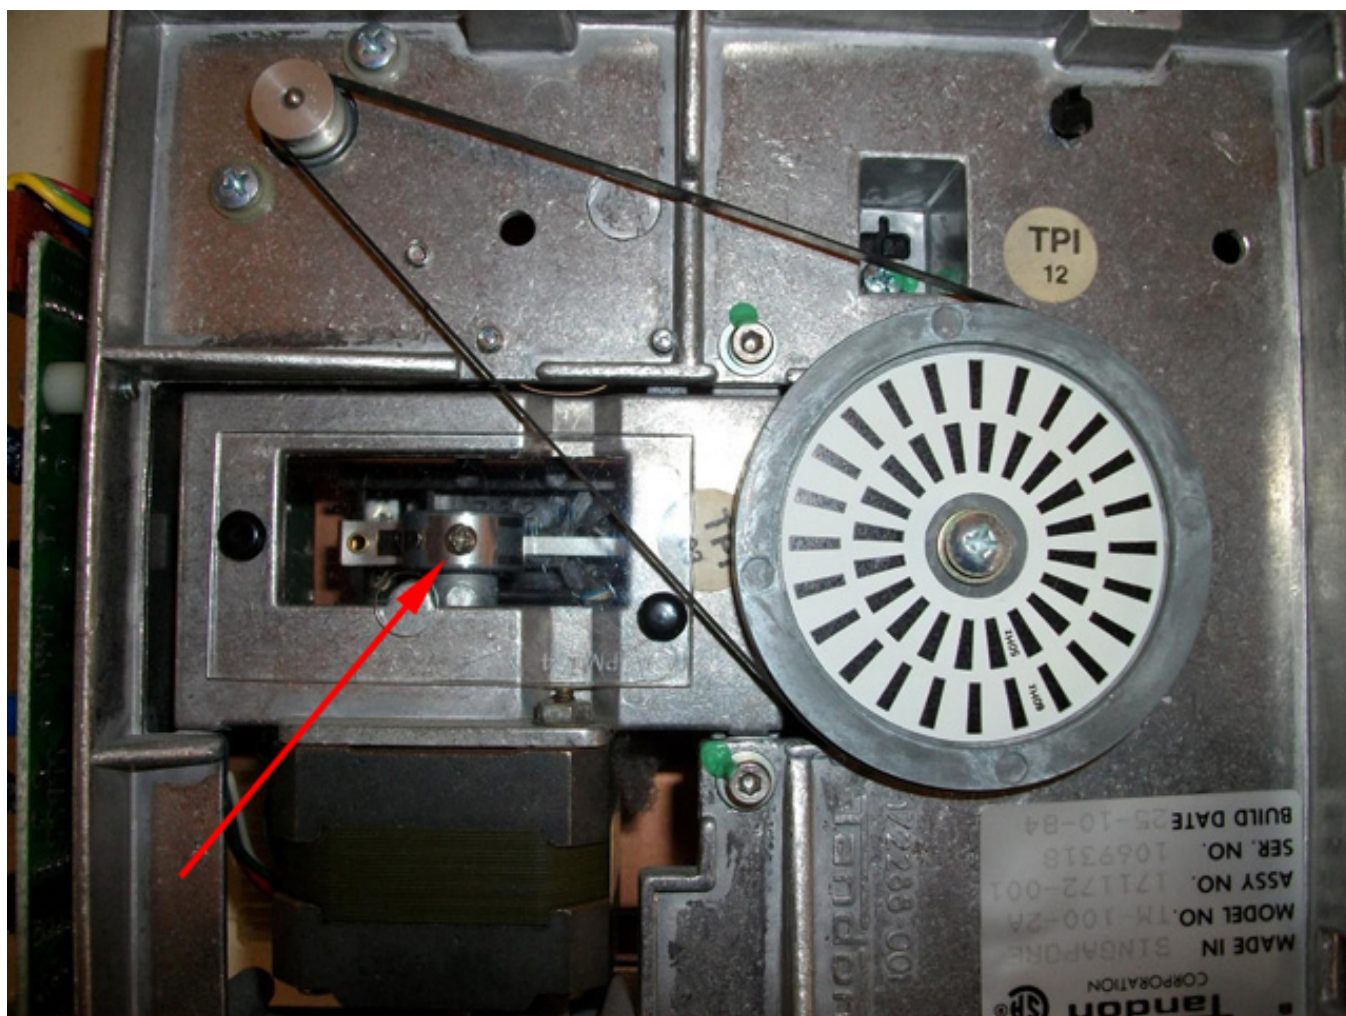
1. Check that the "head split-band" screw on the stepper motor (see photo 1) is tight, as these commonly come loose, causing inconsistent tracking errors. Remove one plastic pin & swing cover to access this screw (photo 2).

Photo 1. The head-split band screw on the stepper motor under its plastic cover

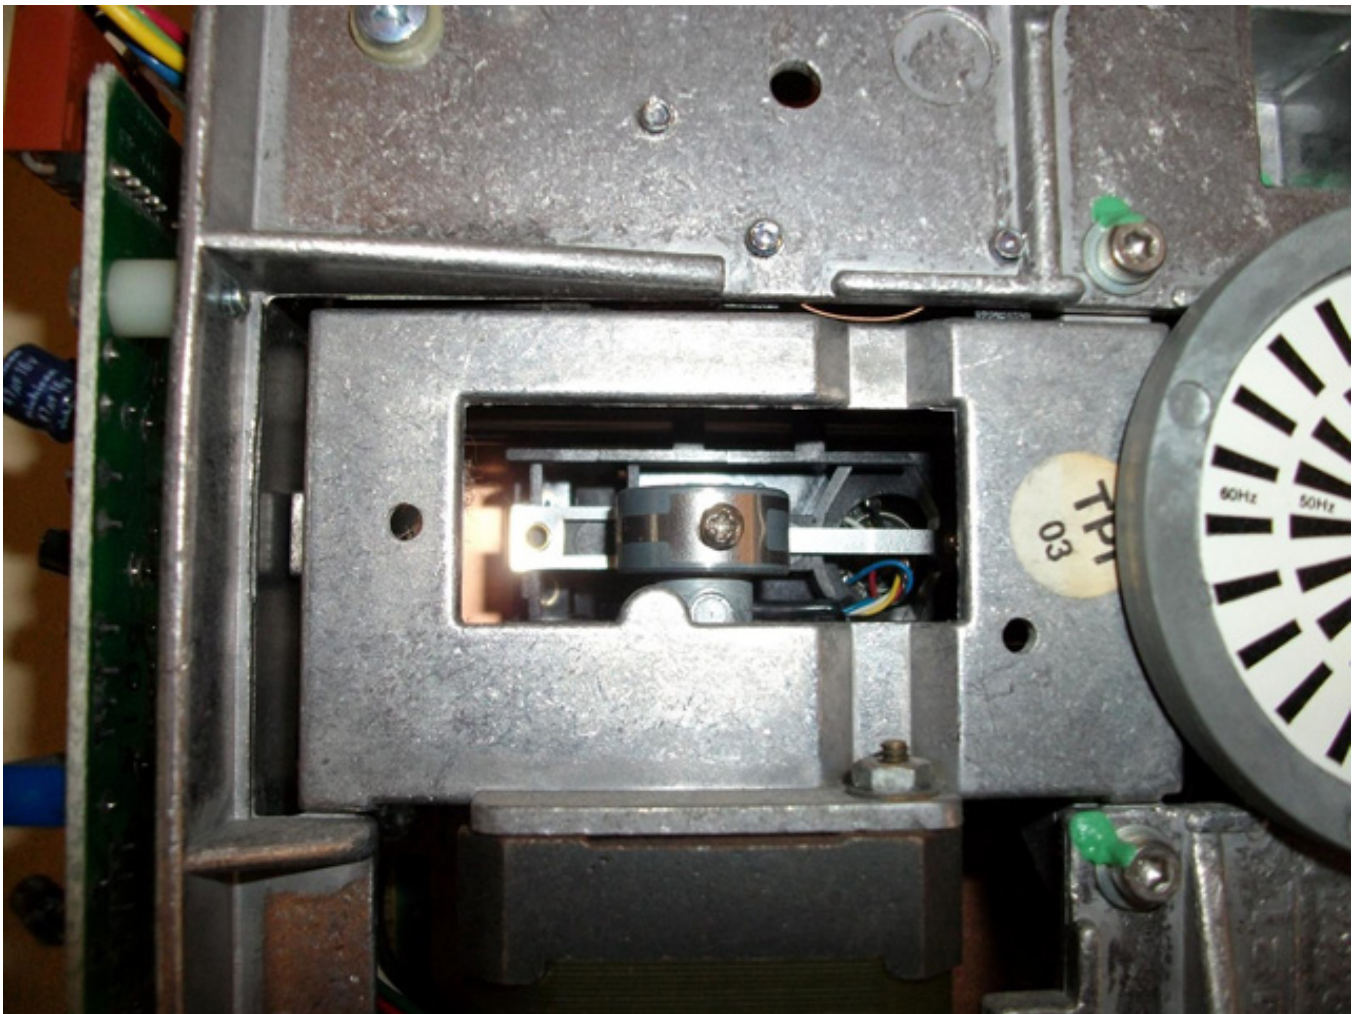
Photo 2. Plastic cover now removed allowing access

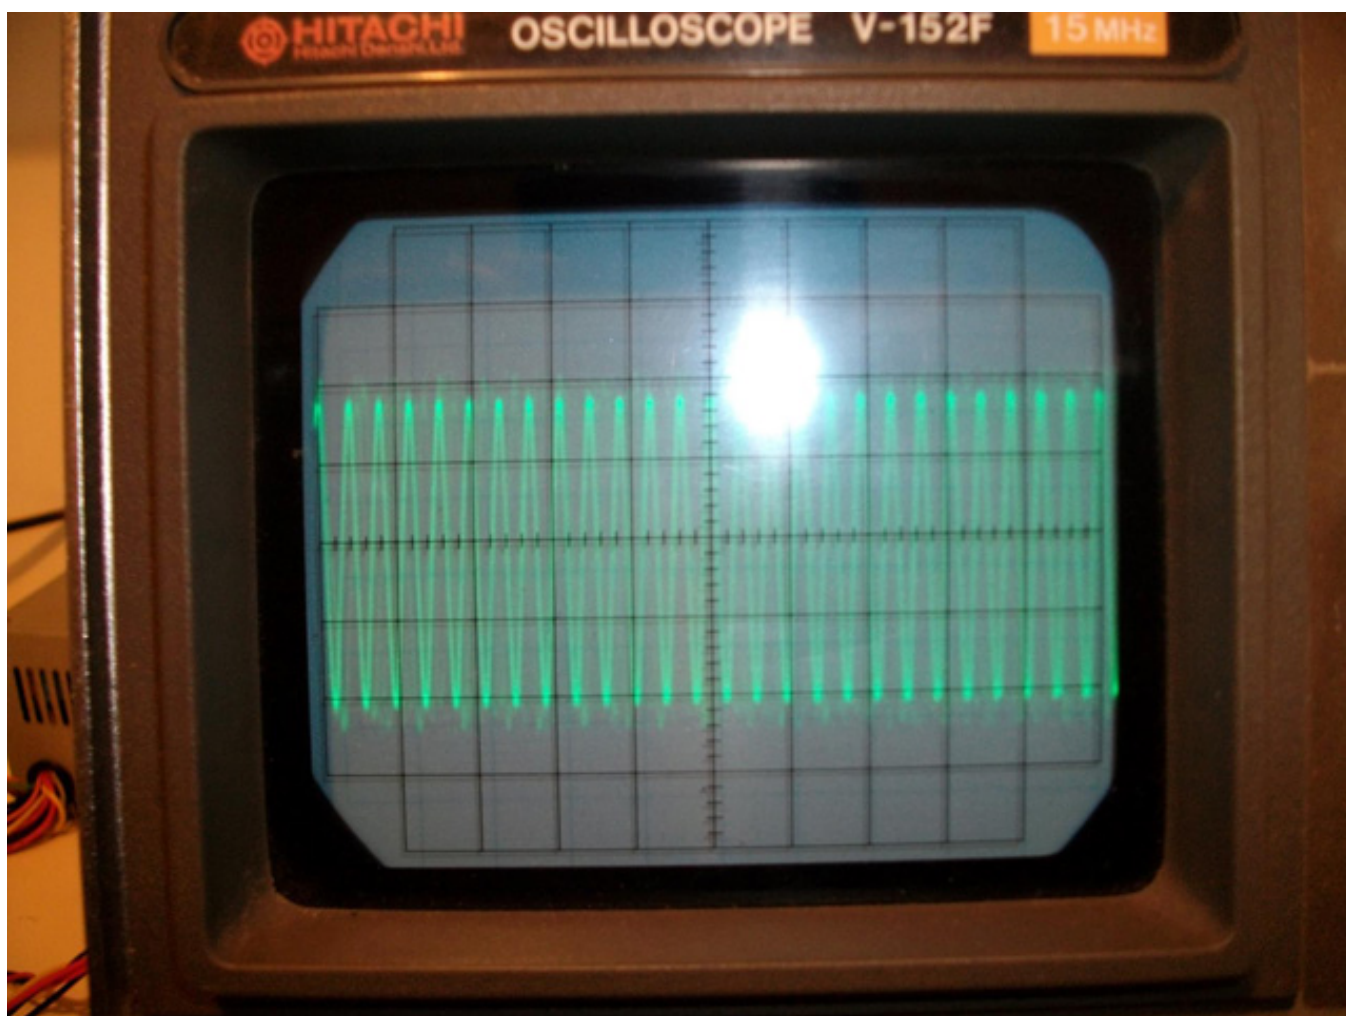
4. Connect scope to TP1 or TP2 (ground of scope to TP6) & you should see a signal of 0.3V to 0.6V peak to peak (see photo 3). On my scope I use these settings: 0.1 Volts/div and 20 usecs Time/div. (If you can't see a signal, replace the floppy in the drive with one that has been written successfully to by that bad drive. This will show the best-case signal – what you'll aim for when reading a floppy from a good drive. This will also verify your scope settings, connections. Once a signal is established, re-insert the above floppy from a good drive).

Photo 3. A strong signal from the drive head positioned over a track

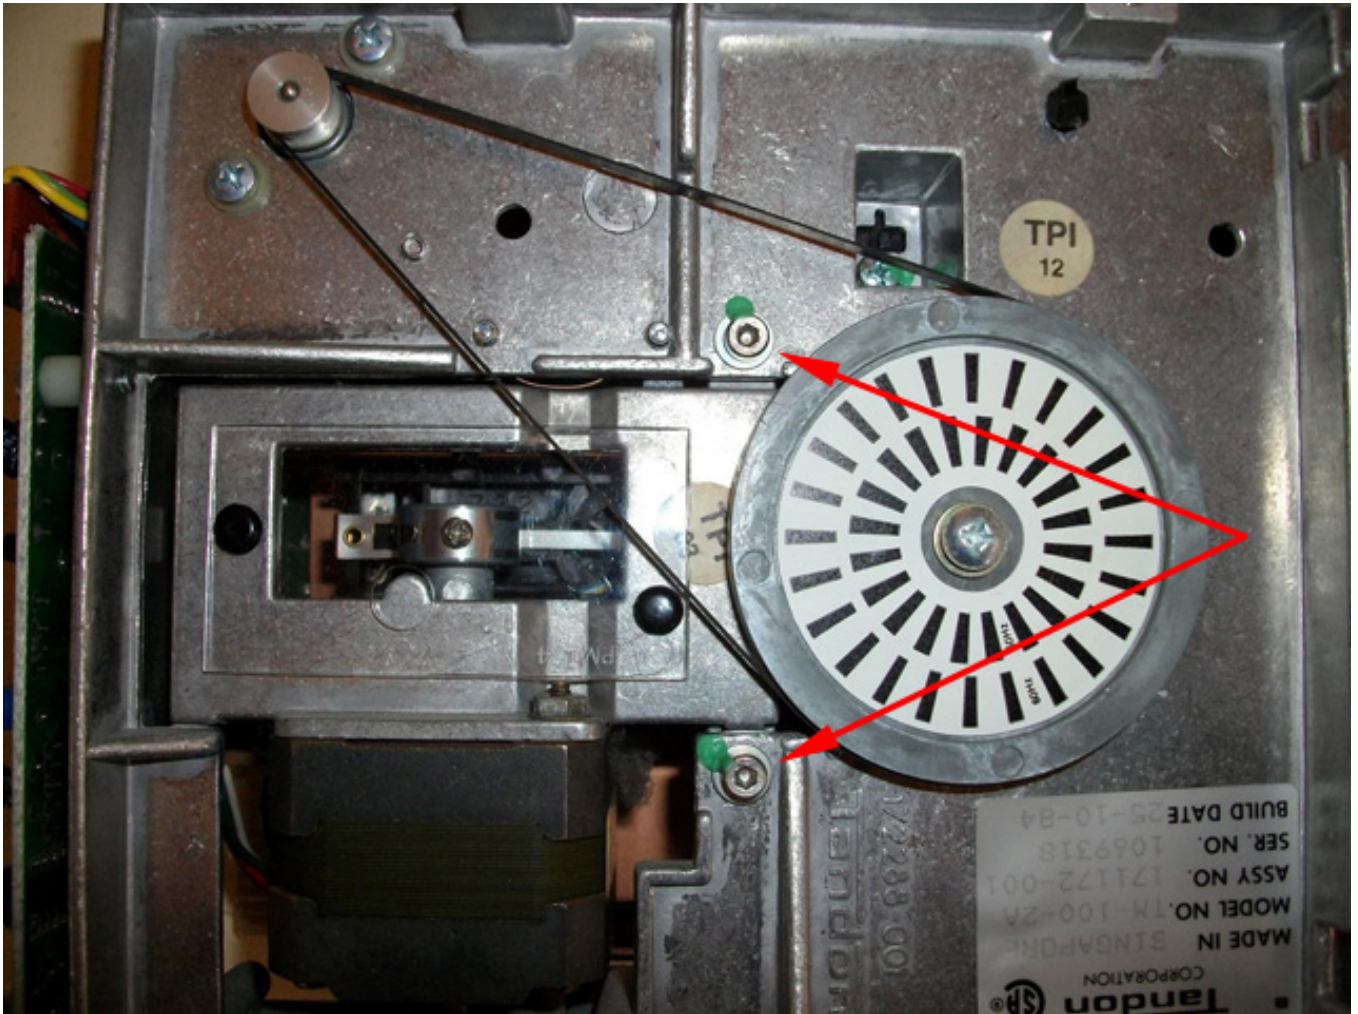
Photo 4. Retaining screws underneath drive

5. Loosen the two retaining screws underneath (see photo 4) and the one on top beside the Adjustment cam (see photo 5). To avoid shorting the pins above the Adjustment cam, either protect these with some insulation, or use an insulated-shank screwdriver to adjust the cam screw. (see

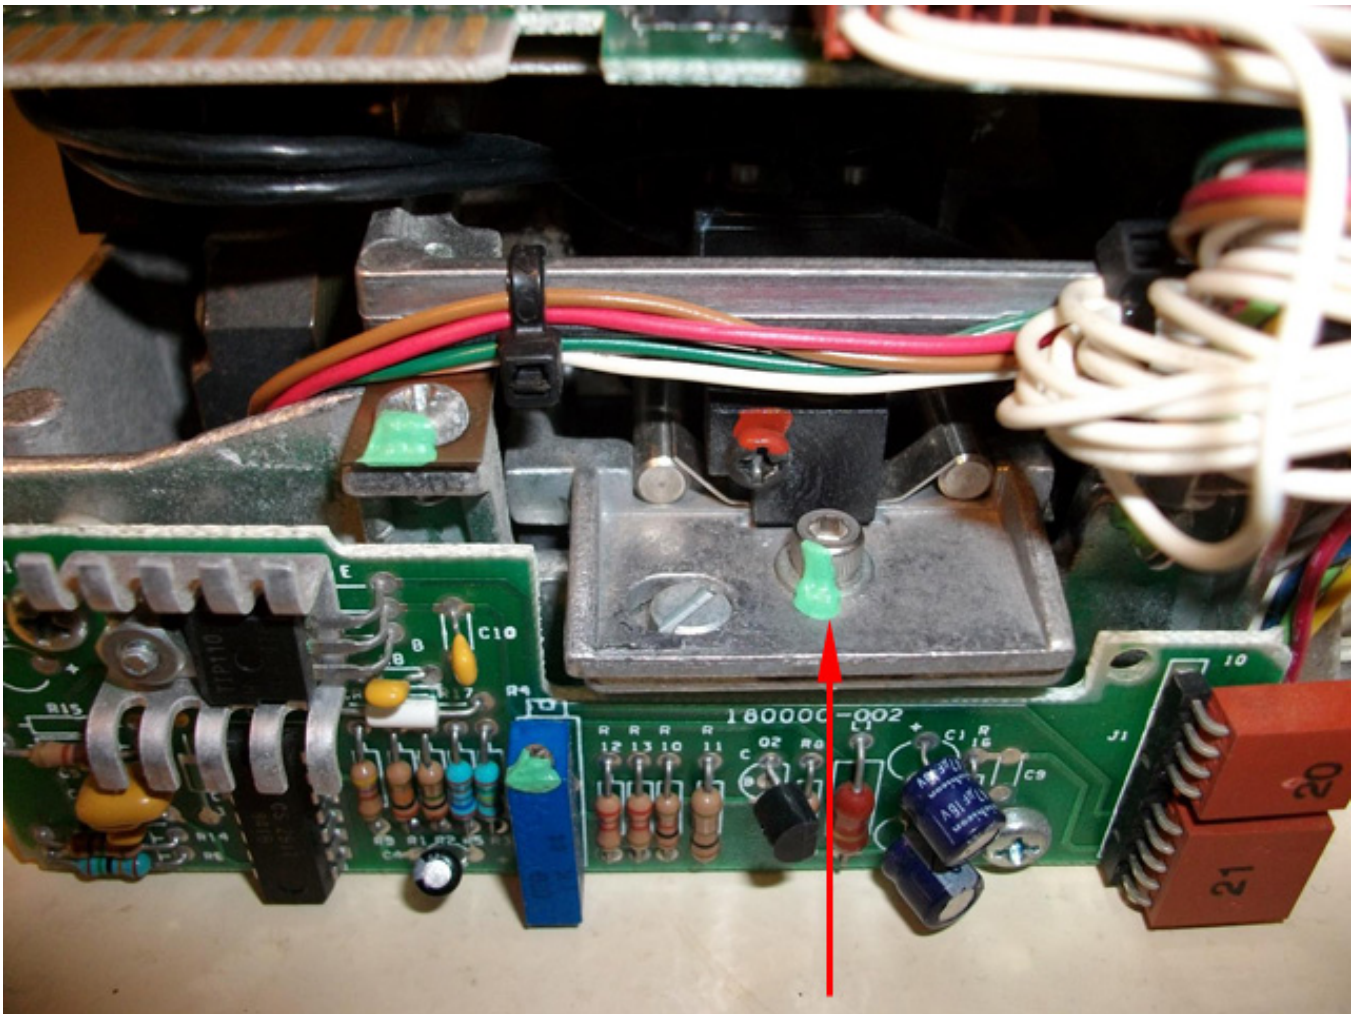
Photo 5. Top retaining screw

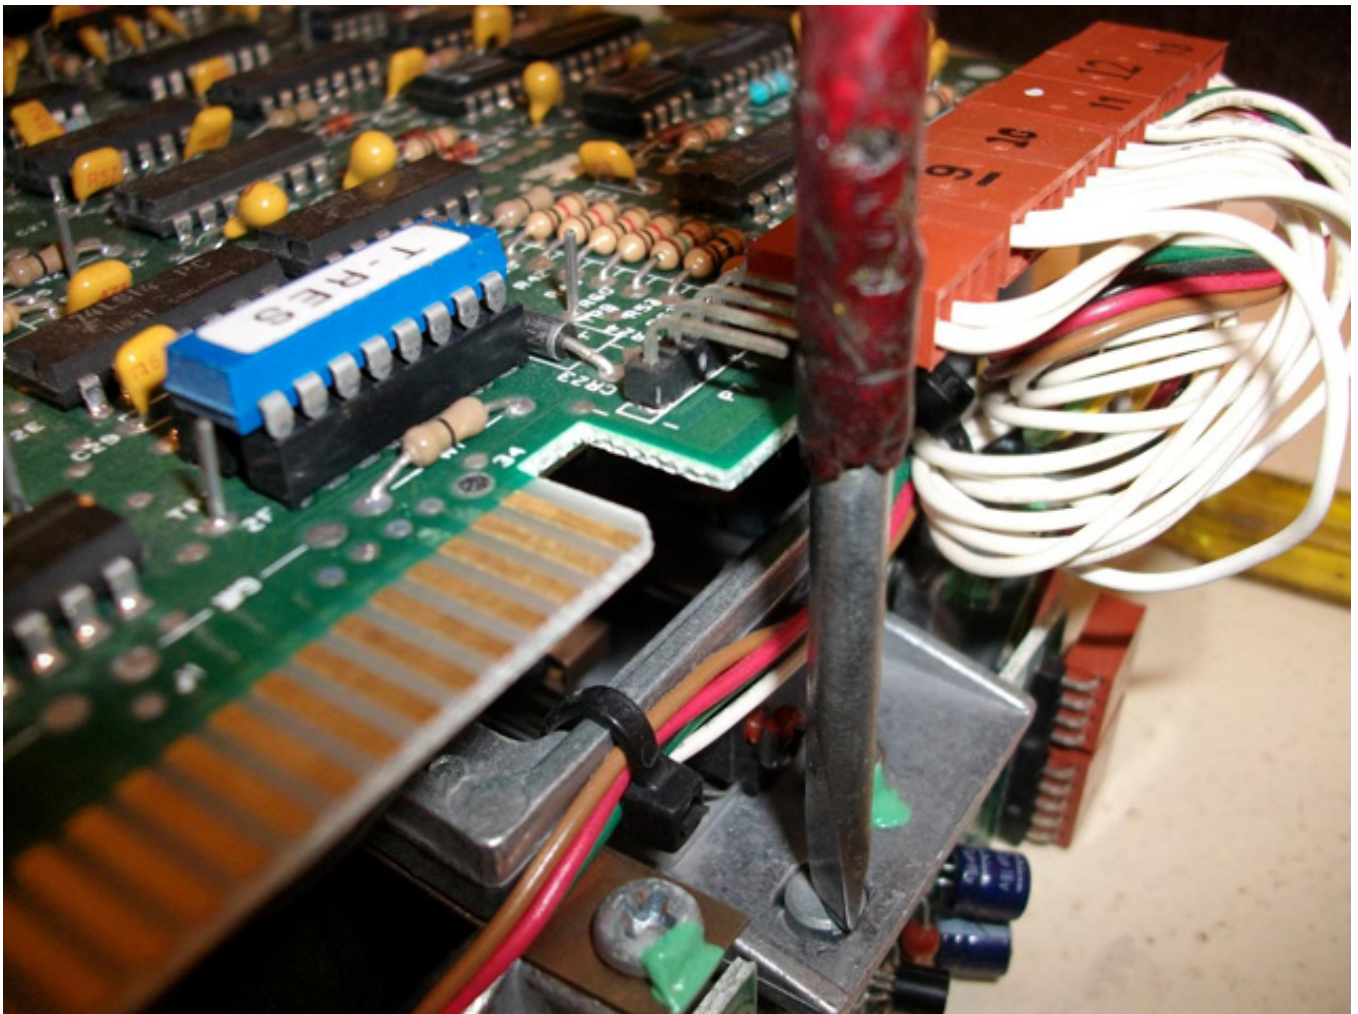
Photo 6. Adjusting the cam screw. Note the insulation to prevent shorting of the pins on the circuit board

photo 6). Turn the cam slowly, no more than half a turn in any direction, while observing the scope and aim for the maximum signal.

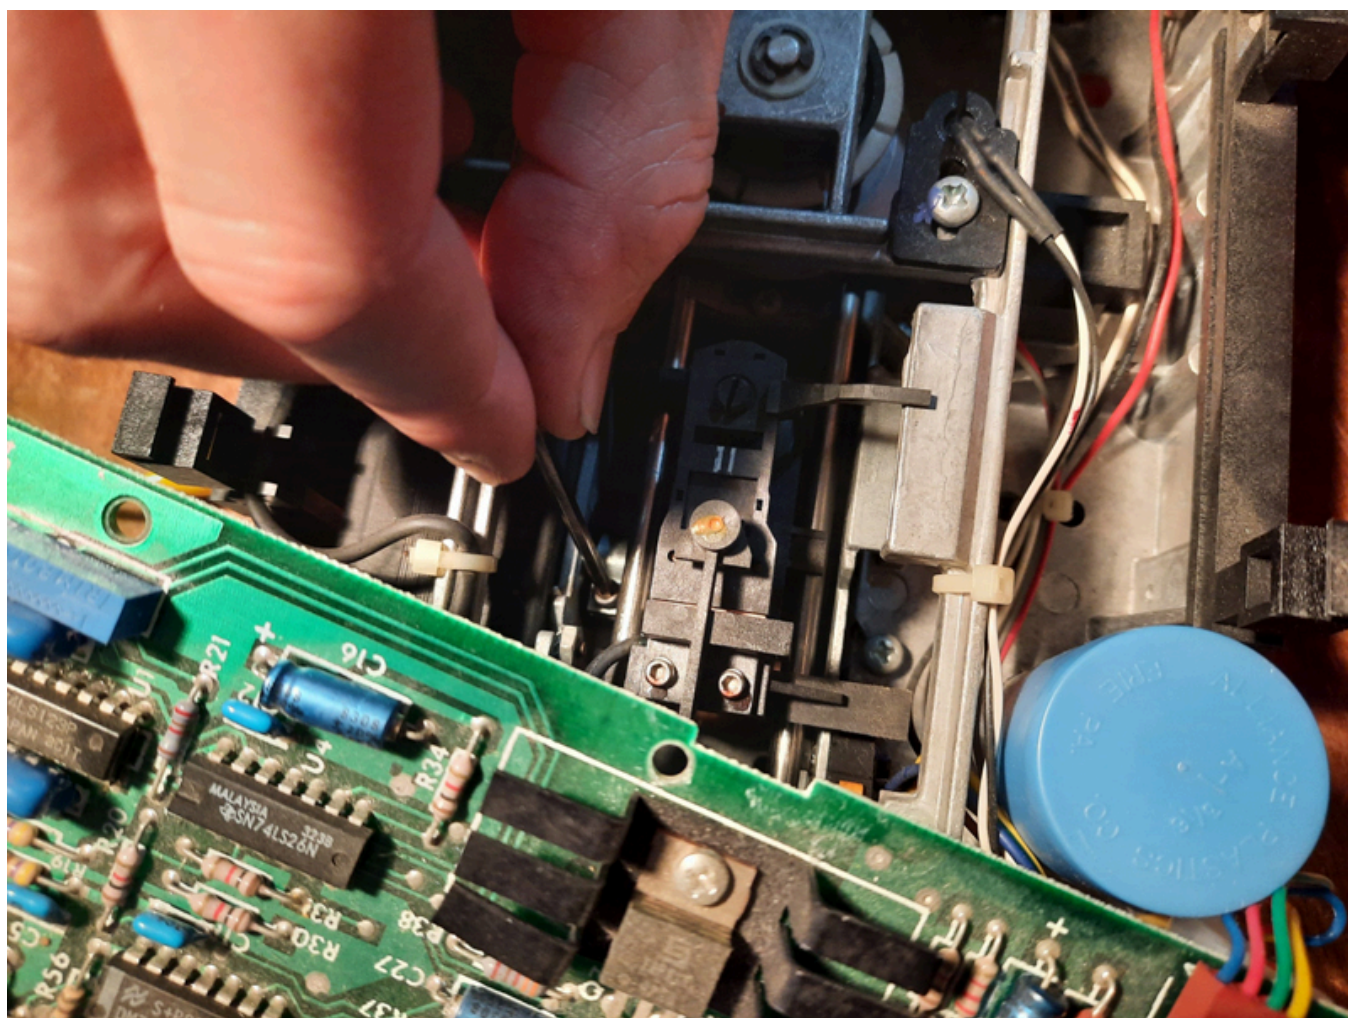
What would make the drive suddenly jump so far out of alignment? Acting on a hunch, Philip checked the screw on the "stepper motor coupling clamp" (Figure 3a and 3b). Hmm...This wasn't fully tight! Could this have caused the stepper assembly to jump a couple of tracks?

Figure 3a. Tightening the stepper motor coupling clamp

We tightened the stepper motor coupling clamp screw and at this point also serviced the drive with a drop of oil in the appropriate places (each end of stepper motor & also the clamping hub). We also cleaned and silicon-greased the rails.

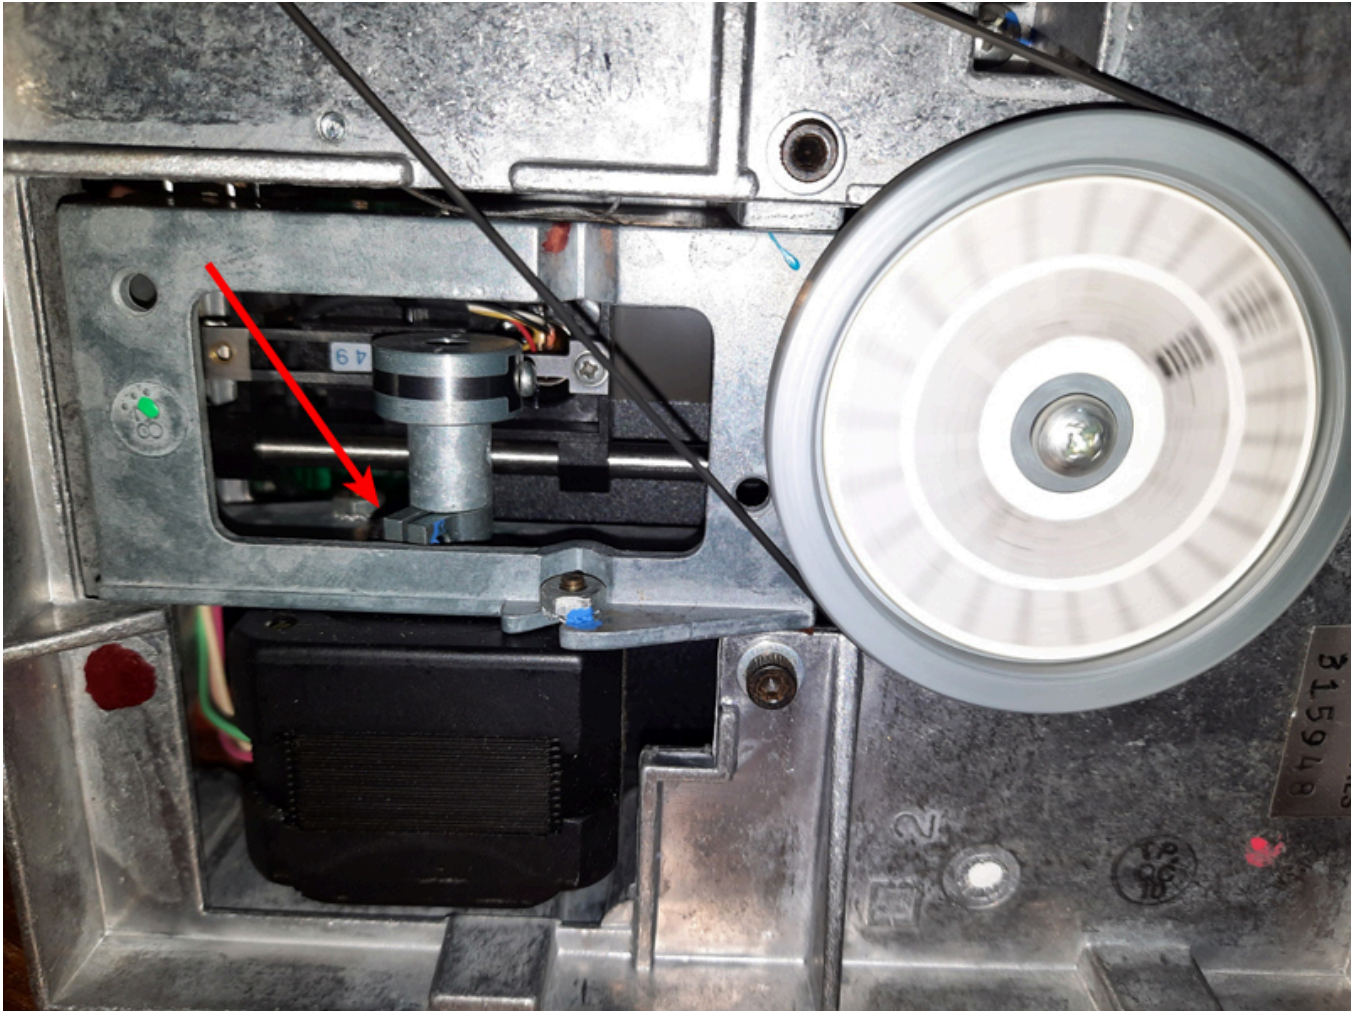
Figure 3b. The stepper motor coupling showing the position of the clamp screw (hidden in photo)

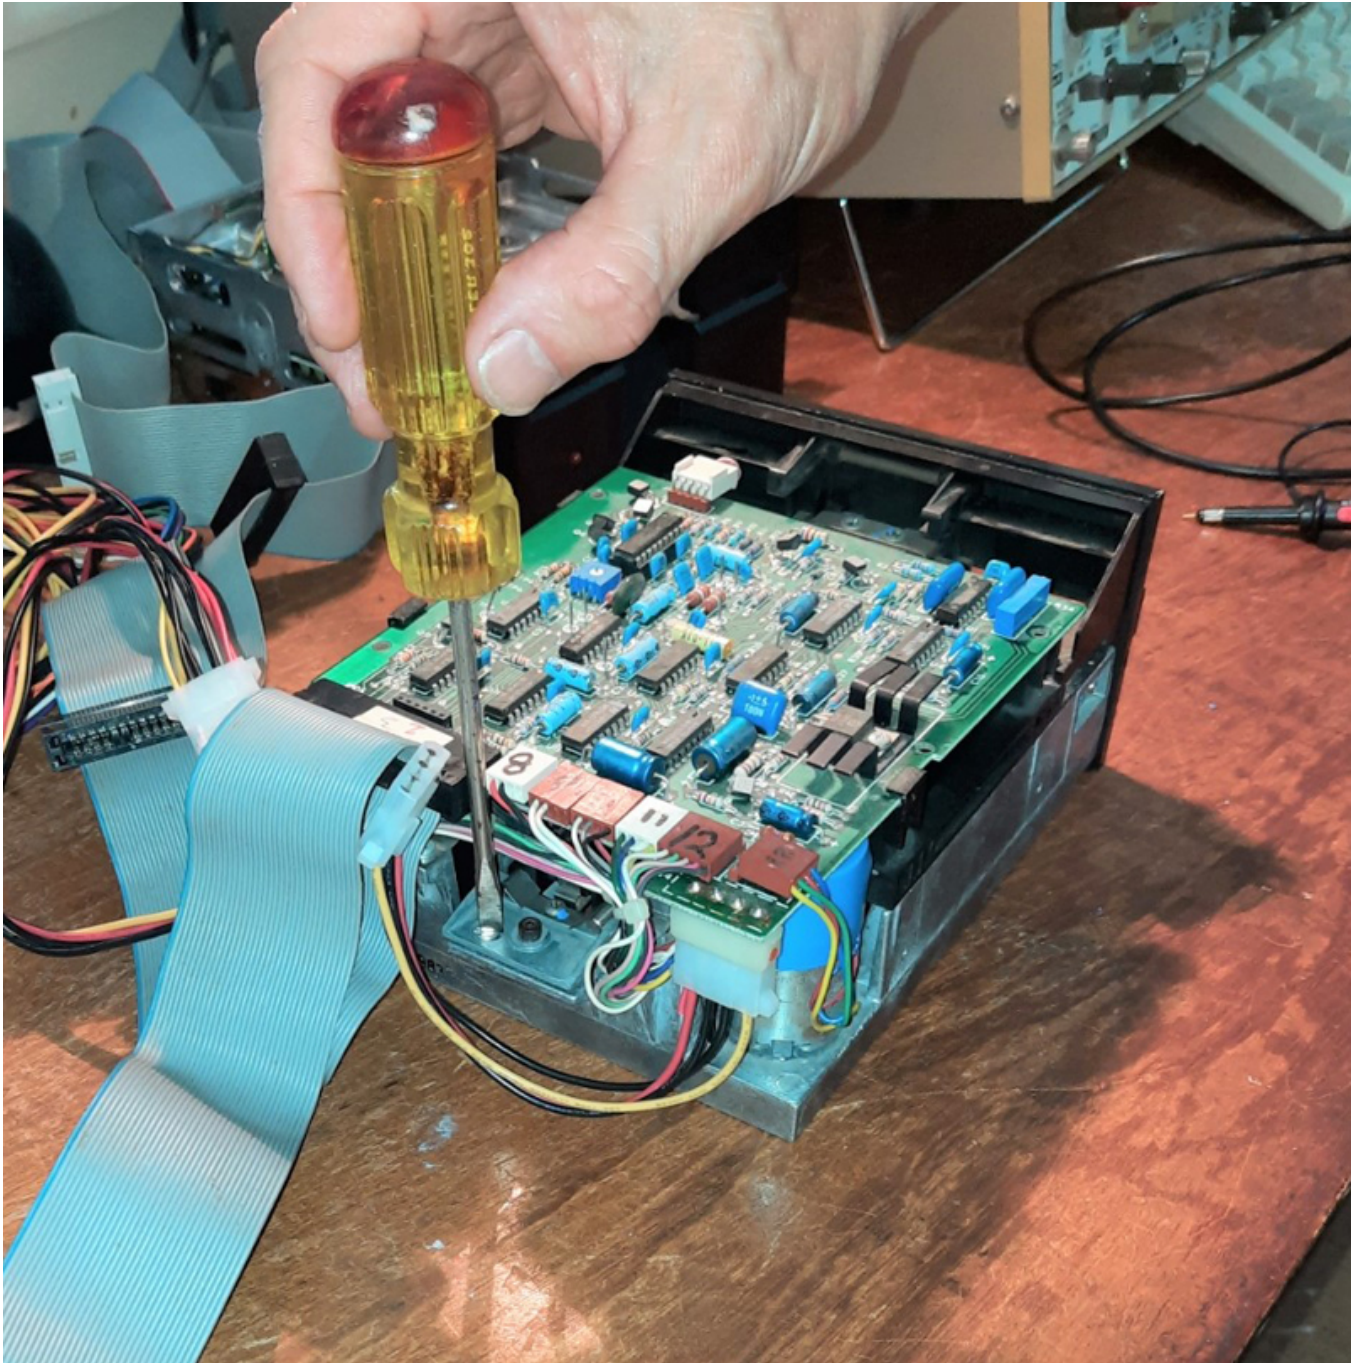
Figure 4. Aligning the heads with the alignment screw

Time to get aligning. Using a combination of oscilloscope, disks formatted in a known-good drives and ImageDisk to position the head over particular tracks, we managed to correct the offset of the drive (or so we thought) by turning the alignment screw. (Figure 4). ImageDisk was now reporting we were indeed on track 0 when we requested a return to track zero.

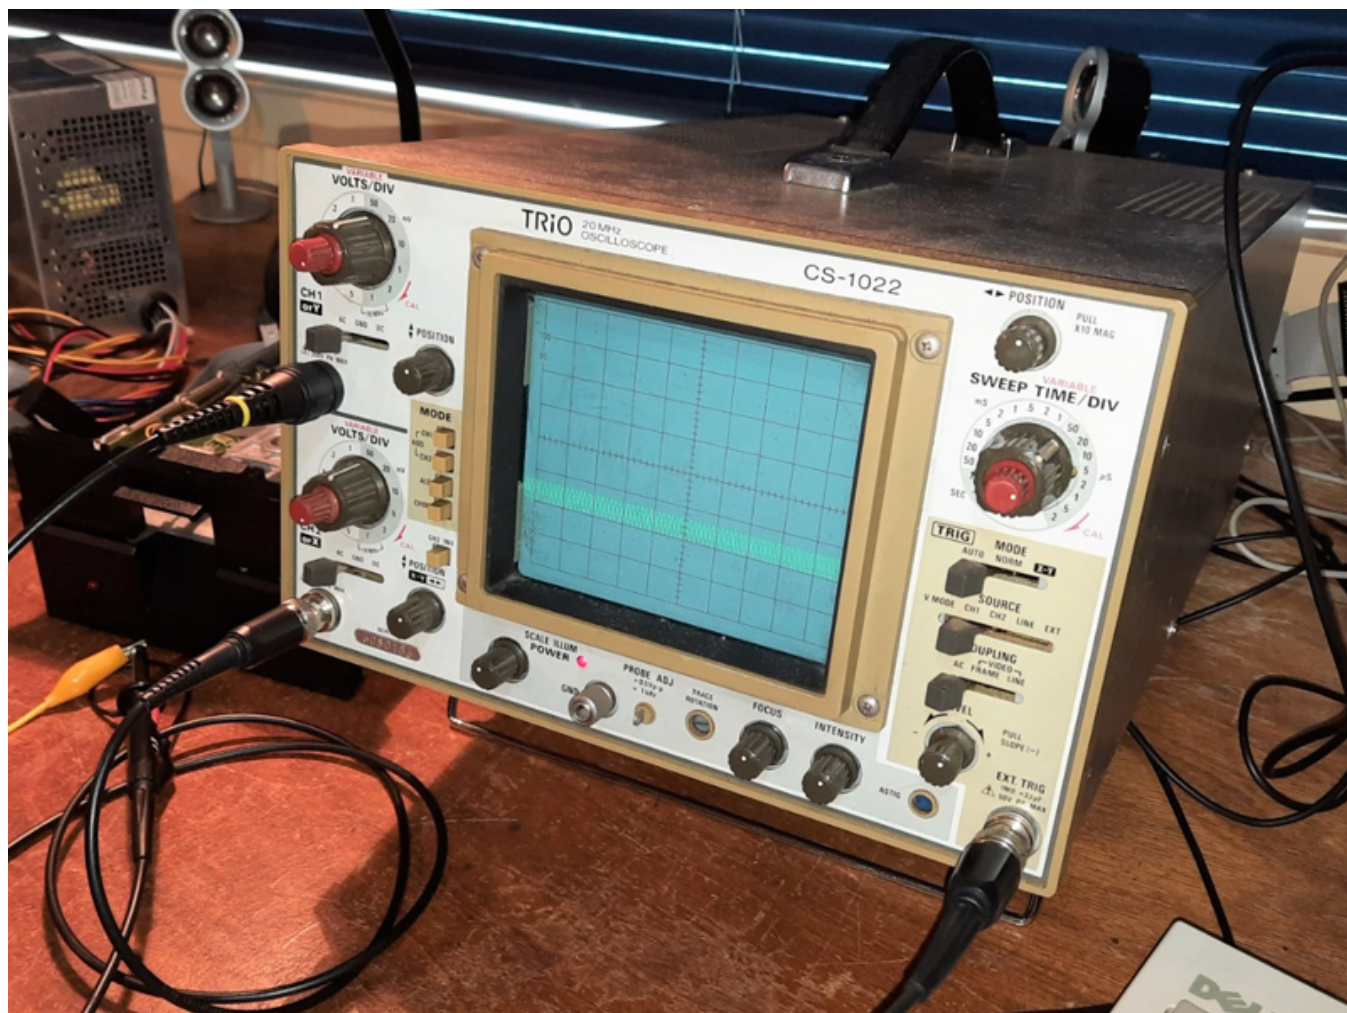
However, the signal appeared faint on the scope at about 35mV?? (Figure 5). A good signal should be 250mv if not more. Our newly aligned drive gave the occasional successful read but only after several tries. We compared the same signal on a good drive using known-good PC and LS-DOS disks and found the faulty (now adjusted) drive's signal over tracks was only about 1/7 the strength compared with the good drive, even at peak adjustment.

Figure 5. A weak signal, but the best we could get via the alignment screw
(note: each divisions is 50mv)

Why couldn't we get a stronger signal? Philip figured this may indeed be because the loose stepper coupling had slipped previously by two tracks & that the alignment screw cam might not give us the range of adjustment necessary to correct this.

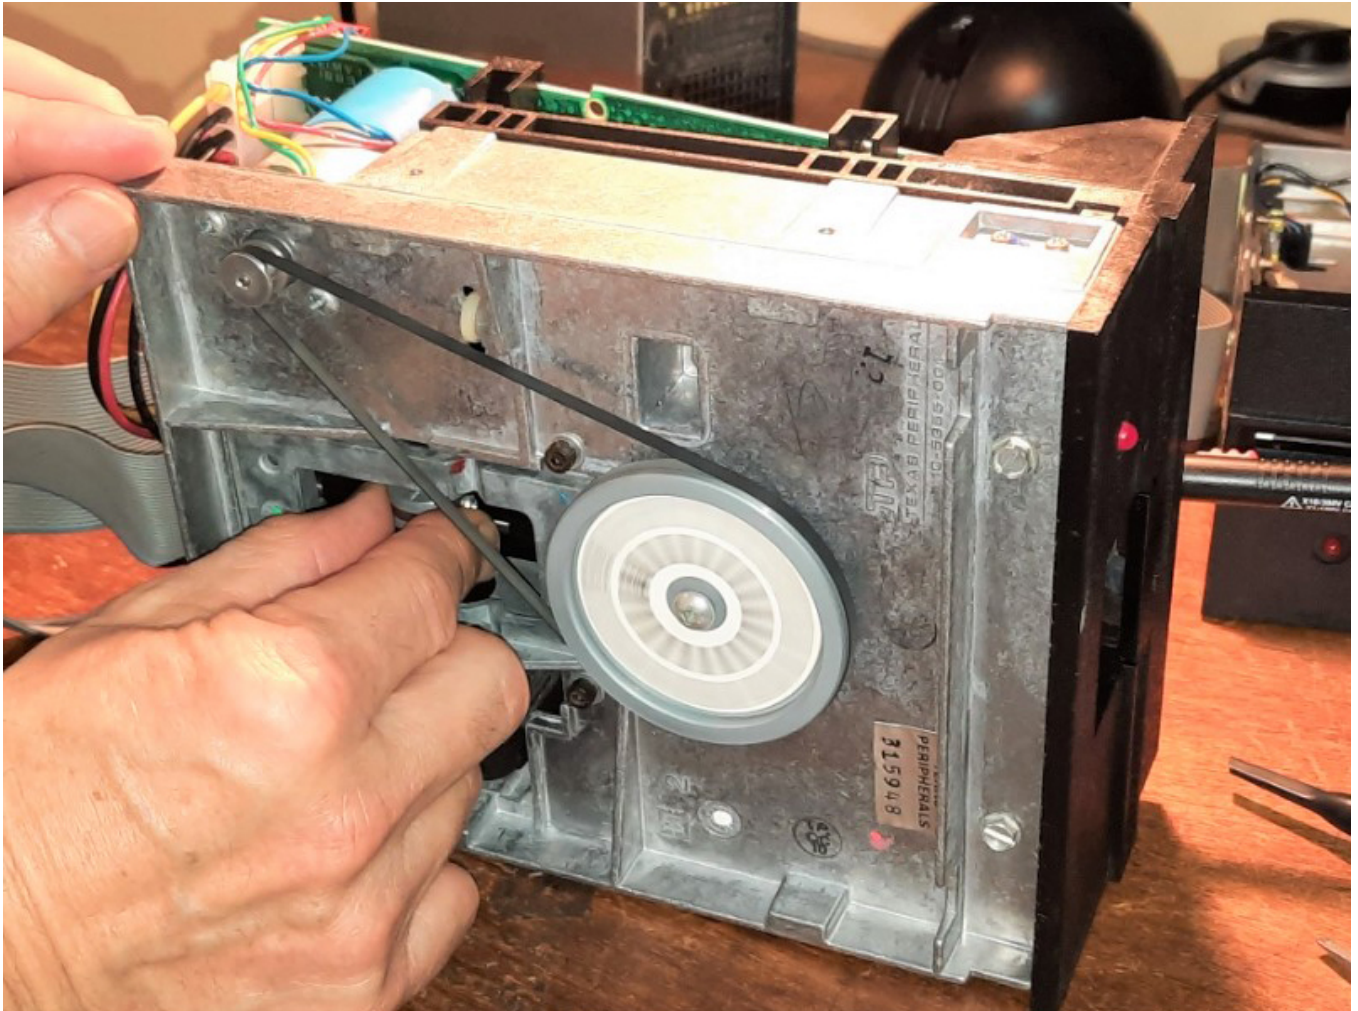
Figure 6. Turning the Stepper Motor Coupling

We needed a coarse adjustment! To achieve this Philip loosened the (retightened) coupling clamp screw & adjusted the stepper coupling manually to move the head independently of the stepper motor (Figure 6).

He merely turned the coupling making sure ImageDisk still displayed the track id that matched the selected track, then adjusted the coupling it until the signal on the scope was as strong as it could be.

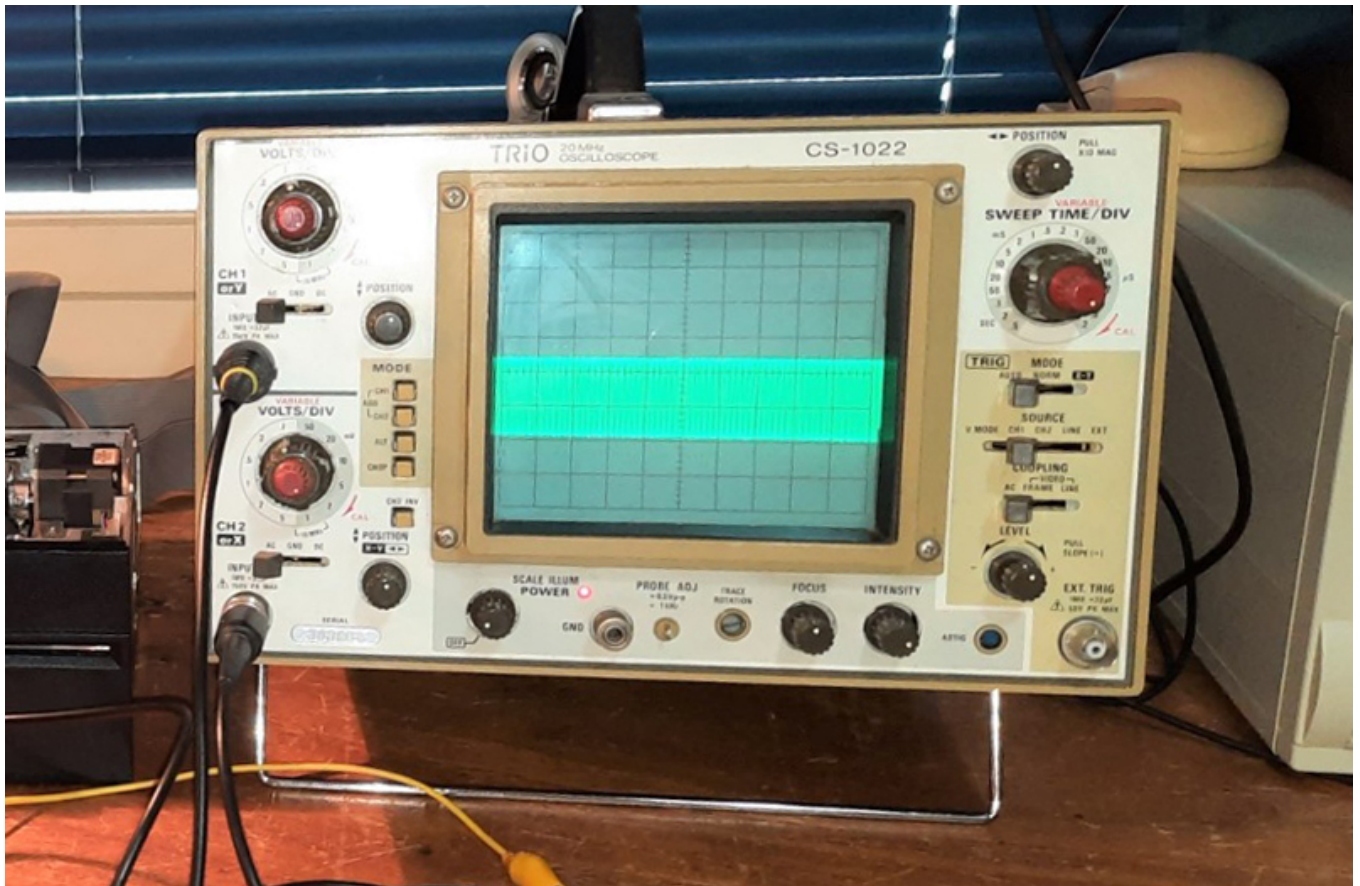
*Figure 7. A strong signal after "coarse tuning" with the stepper coupling
(note: each division in this case is 100mv)*

After retightening the stepper coupling screw, we then fine-tuned with the adjustment screw cam to ensure we were getting the best signal we could. (Figure 7)

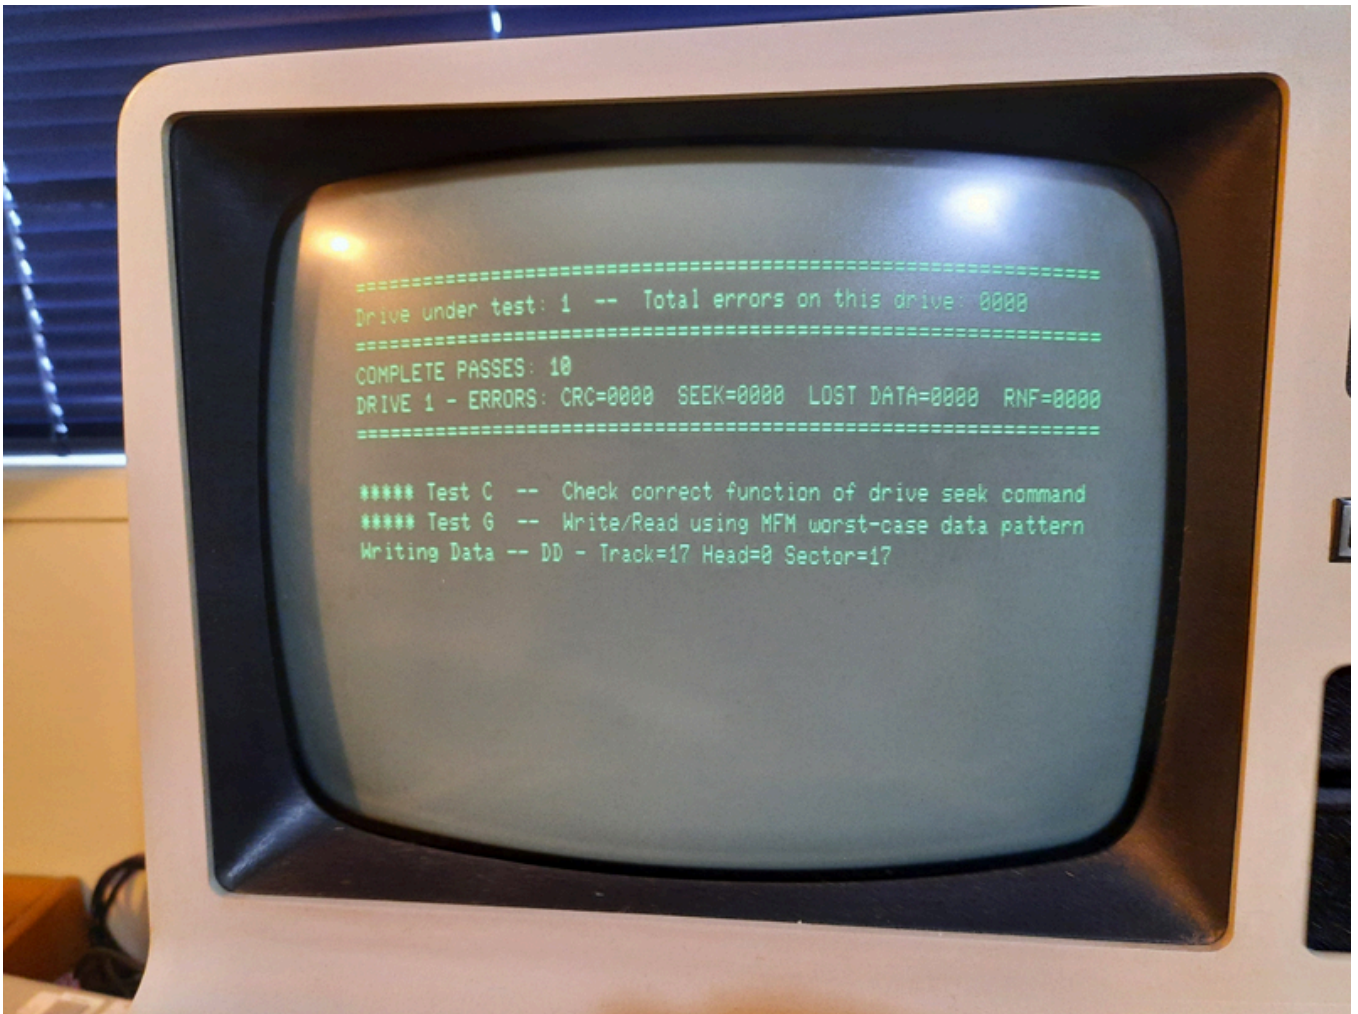
Finally, we tightened everything up, connected our drive to the TRS-80 and exercised it thoroughly with floppy doctor. The drive now worked perfectly and with complete interoperability! (Figure 8).

Figure 8. The drive passes all tests with flying colours including interoperability

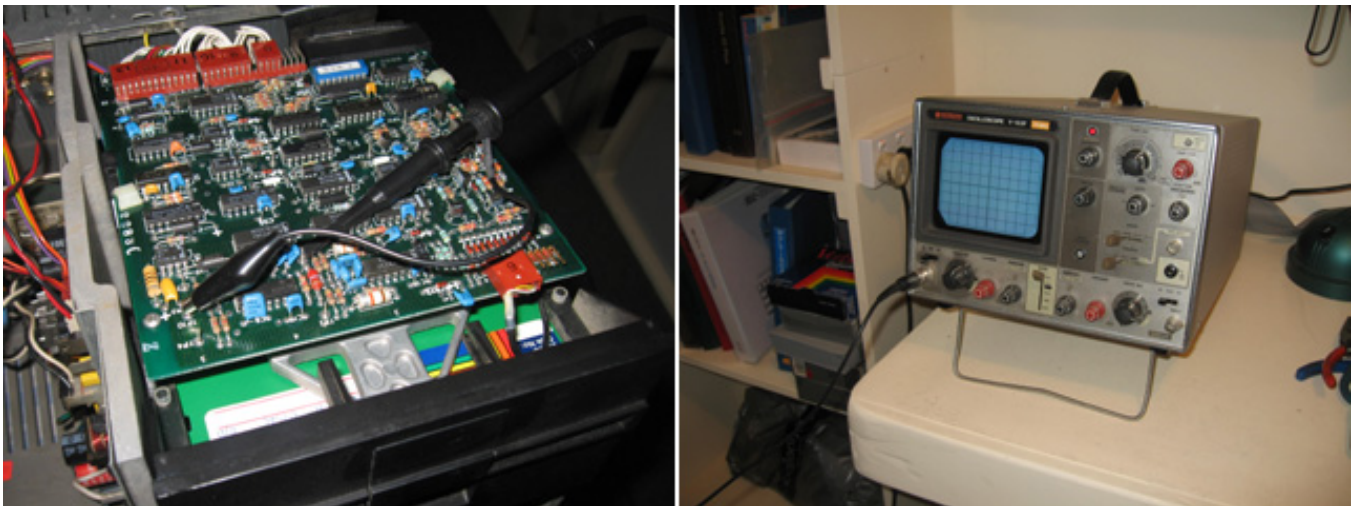
I connected my scope up to Terry's drive, inserted the formatted disk (as above) and found a lousy signal. A good signal on my scope is about 0.3V peak to peak from TP1 or TP2 when reading over any given track. This I determined from measurements during past service 'sessions' with my Model III. Adjusting the Adjustment Cam, after loosening the retaining screws (as detailed in the TM100 manual) brought up a nice big signal. At this point I lock the retaining screws (only mildly tight) then step over the disk to ensure all tracks produce a decent signal. It's worth noting that with the higher tracks (above say track 30), it is normal that there is a substantial drop-off in signal (by as much as 30%) as there is less media in those inner tracks (smaller circumference). Sometimes it takes several adjustment attempts to get an overall good signal. I then lock down those

Photo 4. Probing the drive for radial alignment
