Adjusting the radial alignment a Tandon TM100 -2A drive without an alignment disk

Aligning a full-height floppy disk drive when the alignment screw proves inadequate. Check the stepper motor coupling!

Fixing a Tandon TM100 drive on a Kaypro II

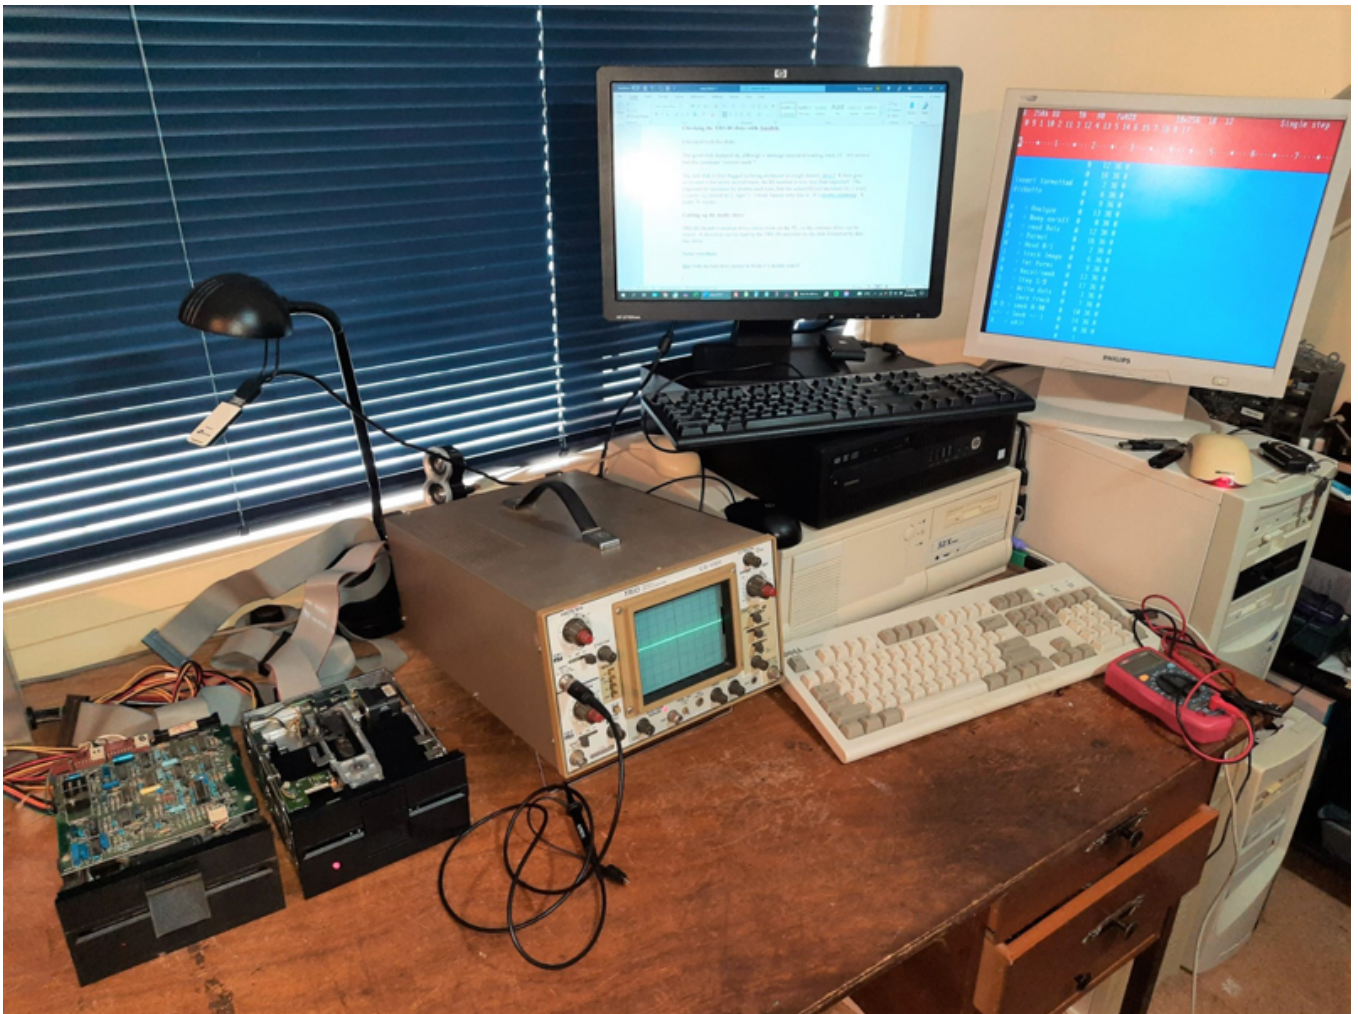
Figure 2. The workbench ready for action!

The drive concerned was the top drive in the TRS-80 Model 4 above. It could format and write disks just fine. It could also read its own written disks. However no other drive could read them! There was no interoperability.

Using the alignment function on [Dave Dunfield's excellent ImageDisk program](#), we soon discovered the faulty drive was badly misaligned. We deduced this because:

Conclusion: The drive was about two tracks out of alignment!

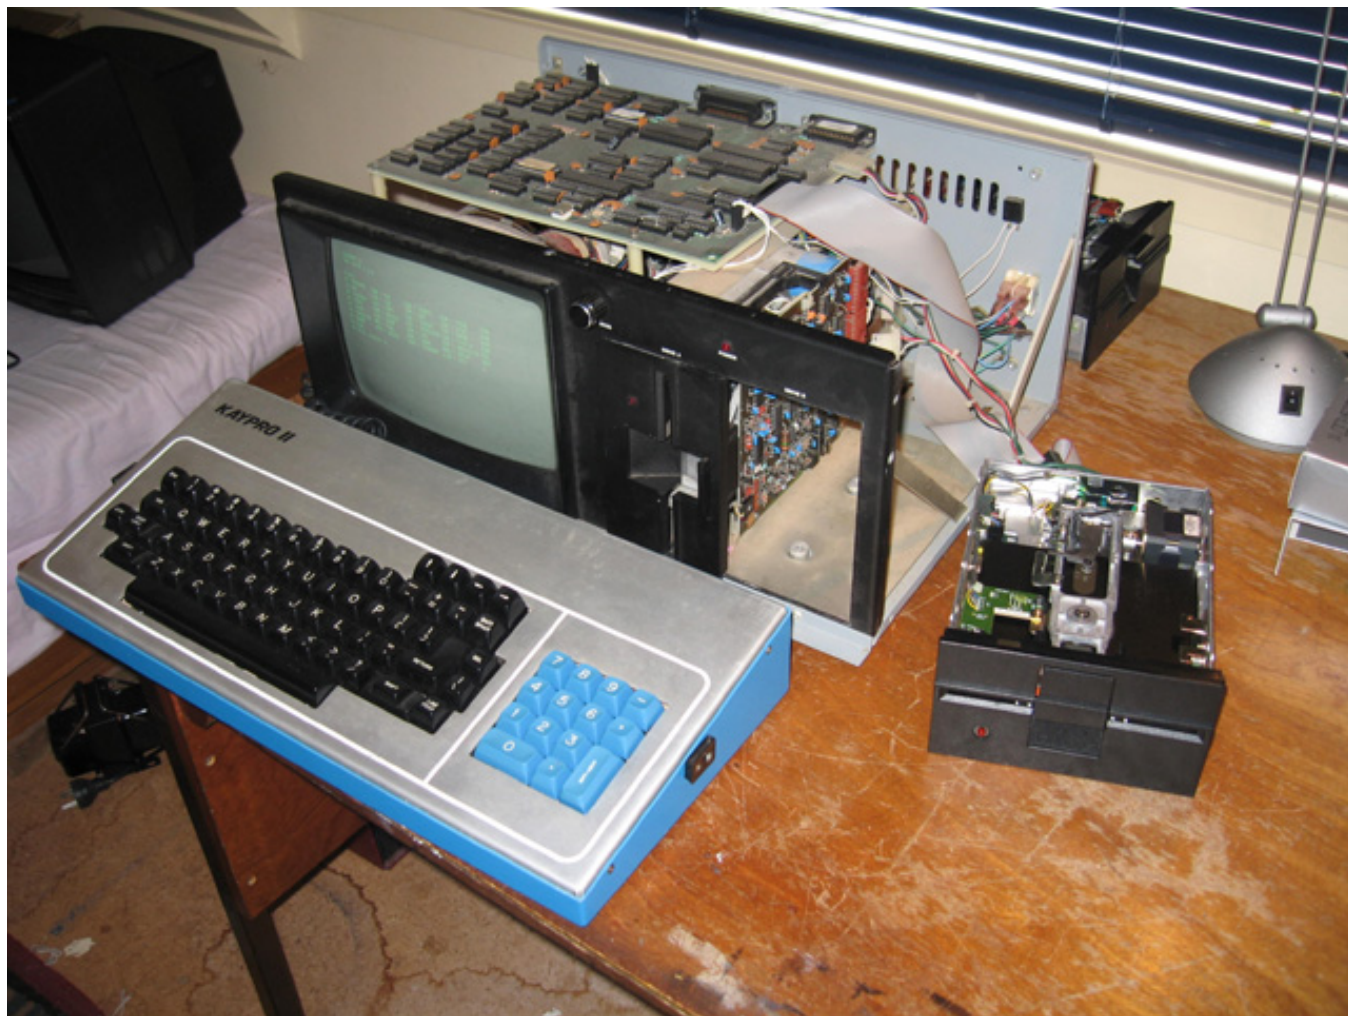
It was then I discovered the Kaypro donor may have misdiagnosed the problem. There was probably nothing wrong with his disks. The problem seemed to lay with the A: drive, which simply refused to boot!

Was it the drive though or the new CP/M disks I'd produced on my PC? Swapping over drive A for B showed that it was indeed the drive as once done, the machine booted perfectly! However, the faulty drive (which was now B) showed the following symptoms:

Photo 1. Kaypro hooked up to another one of my full-height drives to verify the disk controller was ok.
